Keurbooms Estuary floods and sedimentation

Eckart H. Schumann¹

¹Department of Geosciences,
Nelson Mandela
Metropolitan University,
Port Elizabeth, South Africa

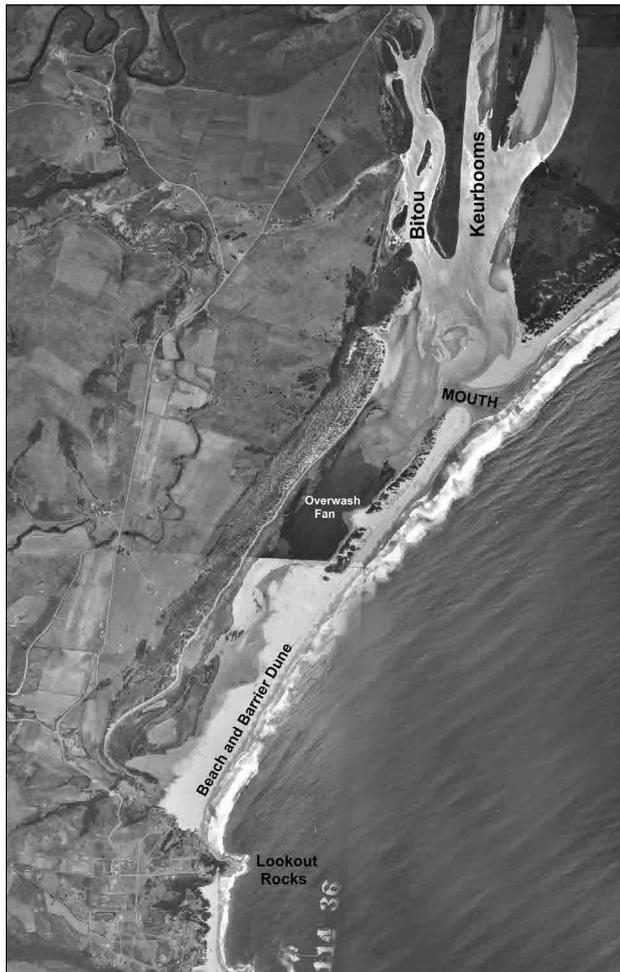
Figure 2: An aerial photograph of the Keurbooms Estuary in 1936.

At the time, the mouth was still situated at the northern end of the barrier dune, while a complex system of sandbanks is evident on the estuary side. The barrier dune extending southwards had a sparse collection of vegetation, while a prominent overwash fan is indicated. Farther south, the wide beach/barrier dune seems void of vegetation, with marine sediments extending some distance into the back-barrier lagoon. On the western side there appears to be a number of channels with zoster-covered sandbars.

Fromme³ analysed the mouth migrations using a set of 14 aerial photographs over a period of 44 years. The first two photographs from 1936 (Figure 2) and 1942 show the mouth still in the northerly position, while all the other 12 photographs located it in the centre of the barrier dune, some 2 km north of the Lookout Rocks. The mouth position over the 19 years from 1961 to 1980 varied over a distance of around 500 m.

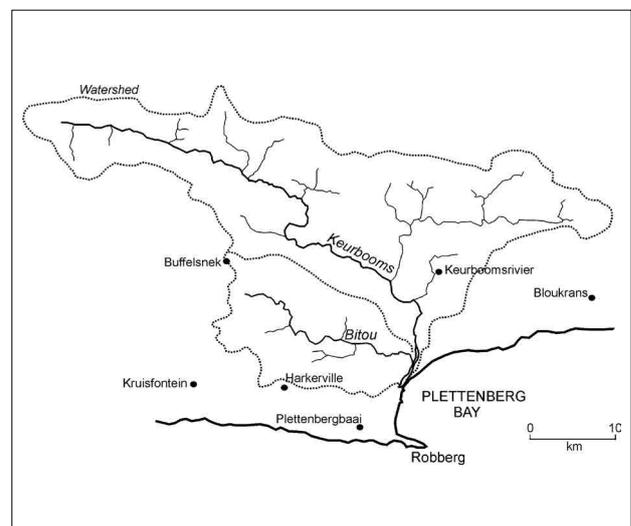
Figure 3: Catchment areas of the Keurbooms and Bitou Rivers.² The rainfall stations used in the analysis are shown.

The catchments of the Keurbooms and Bitou Rivers are shown in Figure 3 and have areas of 859 km² and 237 km², respectively.² The mean annual run-off of both catchments was estimated to lie in the range of 70 x 10⁶ m³ to 160 x 10⁶ m³ by Duvenhage and Morant.⁵ On the other hand, Fromme³ calculated a median discharge of 8.29 x 10⁶ m³ per month over a period of 56 years. These values correspond to an average inflow between 2.2 m³/s and 5 m³/s, although these values include occasional floods, which means that the daily flow from the two rivers is probably considerably less.

Stations were selected on the basis of being relevant to the two river catchments, i.e. they needed to be close enough, and positioned on the southern side of the Tsitsikamma Mountain range. On this basis, the six stations shown in Figure 3 were selected to represent rainfall in the catchments. Mean values for every day over all six stations were calculated, the advantage being that missing values from any one station would not impact too greatly on the final value.

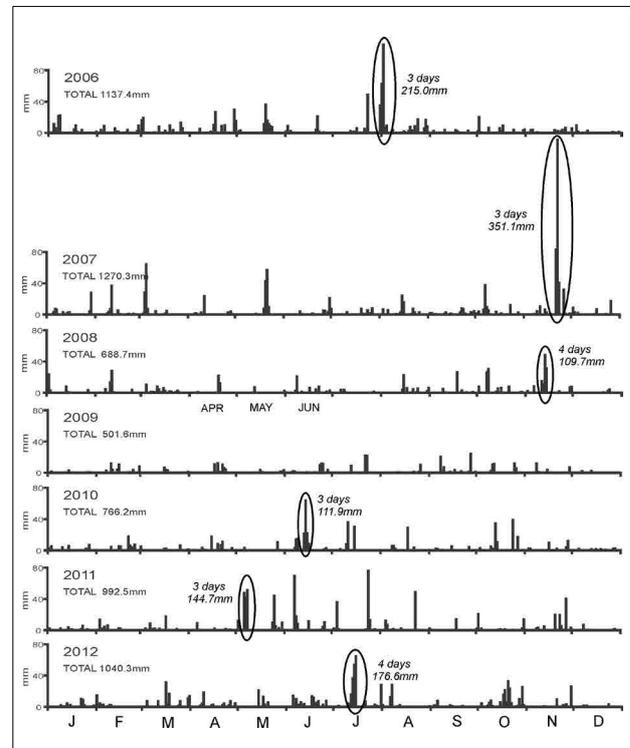
Figure 4: Daily rainfall from 2006 to 2012. Intense rainfall events of more than 100 mm over 3 or 4 days are circled.

Daily rainfall over the years 2006–2012 is shown in Figure 4. Intense rainfall events of more than 100 mm over 3 or 4 days are circled. Figure 5 shows the corresponding water levels at the N2 gauge in the Keurbooms Estuary. A standard symmetrical cosine–Lanczos filter with 97 weights and a quarter power point at 0.035 cph was used to filter these measurements, thereby effectively eliminating periods shorter than about 30 h, and in particular removing the tidal signals.

The correspondence between the intense rainfall events and the elevated water levels in the Keurbooms Estuary are clearly evident. In particular, the floods of 2006, 2007 and 2012 appear prominently, with the major flood of 2007 actually breaking the recording gauge. Nonetheless, there are a number of smaller events which stand out as potentially significant.

Inspection of rainfall records in Figure 4 shows that a total of 109.7 mm of rain fell over the 4 days 11–14 November 2008, but there was only a small corresponding peak in the DWA water level record in Figure 5. Similarly, the 59 mm of rain that fell on 7 and 8 October also only caused a minor increase in water level.

The next appreciable flood to cause major changes in the Keurbooms Estuary occurred over the four days 12–15 July 2012, when 176.6 mm of rain was recorded (Figure 4). The amount of rain is not much more than the 144.7 mm which fell over 6–8 May 2011; however, the water level at the N2 bridge increased by about 2.5 m, and this rise had a markedly different effect on the estuary.

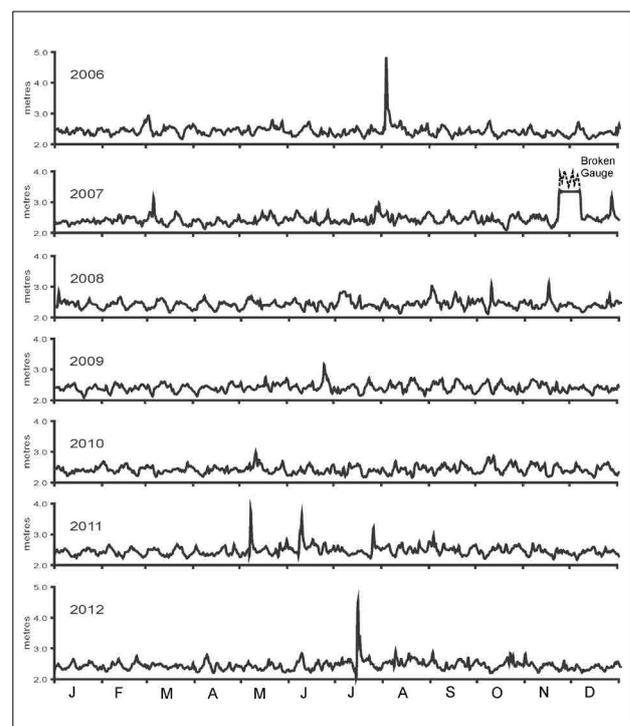
Figure 5: Filtered water levels measured at the Department of Water Affairs N2 water level recorder from 2006 to 2012.

It should be noted that there were several minor floods in 2011 (Figure 5), which caused an appreciable increase in the water level at the N2 bridge – up to 1.5 m. However, it is apparent that the convoluted exit channel could cope with the additional flow, and there were no significant changes in the estuary's morphology.

The impact of a flood will depend on the volume of floodwaters, as well as the resistance to flow of the convoluted backwater channel. Figures 4 and 5 show that there were at least two reasonable floods in 2011 which caused the water levels at the N2 gauge to rise around 1.5 m, however, there appeared to be little impact on the estuary. The flood of July 2012 raised the N2 gauge water level by about 2.5 m, and the impact on the estuary was massive. As already described, this impact was probably because the back channels had become more convoluted and the flood waters breached the barrier dune to find a more direct route to the sea. The high waves and overwash fan assisted in finding a suitable point to breach the barrier dune.

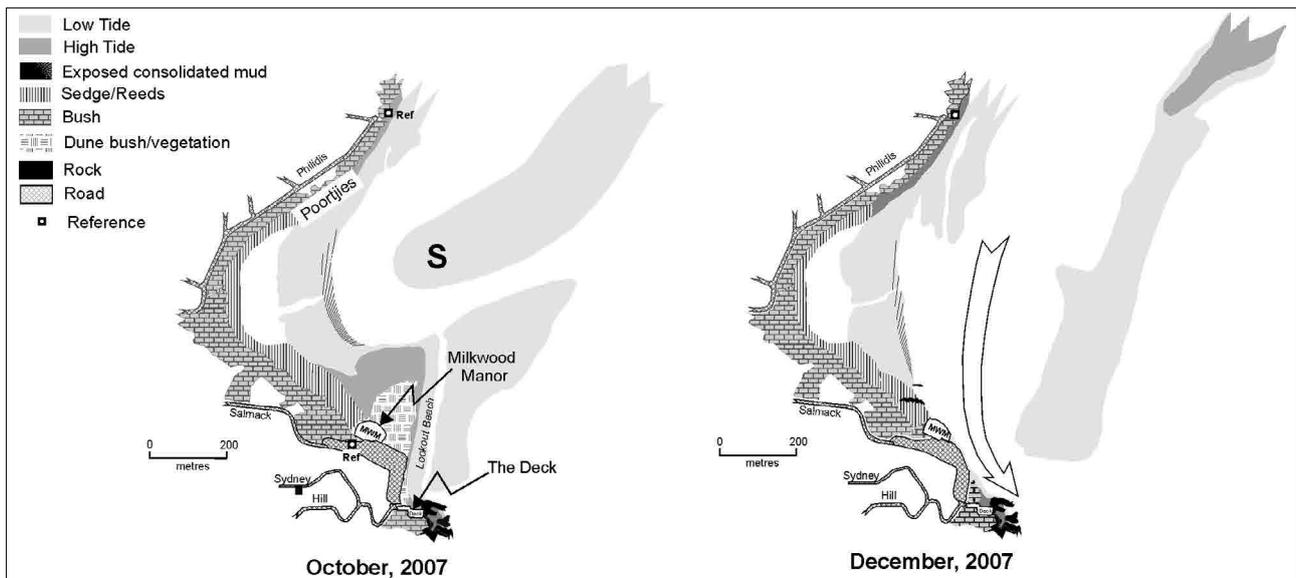
Figure 6: Sediment structure maps in the Keurbooms Estuary on the given dates. The legend gives the structures depicted, while the October 2007 map identifies sites mentioned in the text. The arrow depicts the main floodwater flow.

As indicated, the flood of August 2006, took away about 200 m of the barrier dune at the back of Lookout Beach, including dense bush and dune vegetation. After this flood, the normal estuarine sedimentary processes continued, and the general geomorphology for October 2007 is depicted in Figure 6. This figure also shows the positions of various sites mentioned in the text.

Cooper²³ found that in such tide-dominated estuaries, floods typically erode accumulated sediment and deposit some of it as an ephemeral delta. This is what happened here, and Figure 6 shows that in December

a new subtidal barrier dune had formed with its tip some 400–500 m seawards of the previous position.

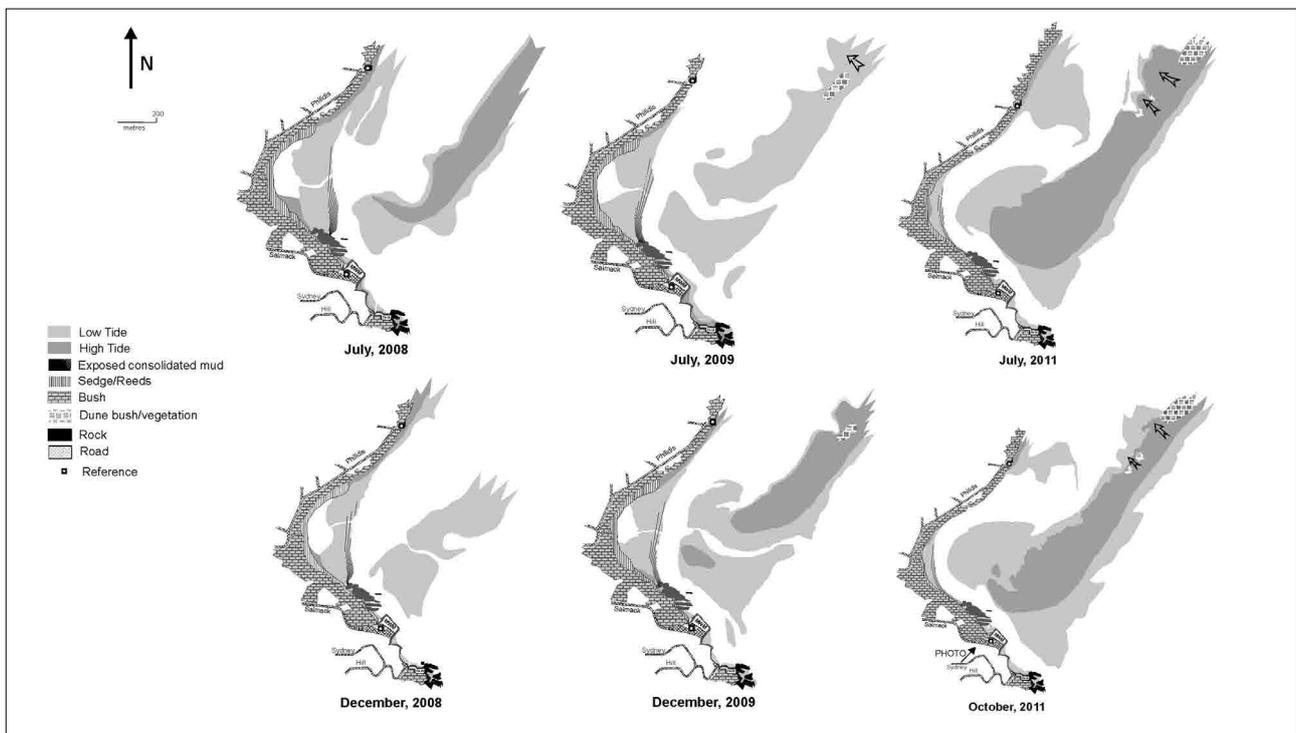
Figure 7: Sediment structures in the Keurbooms Estuary on the given dates. The arrows on the barrier dune indicate washover points.

After the massive flood in November 2007, Figure 7 shows the changes over the next 4 years. It is expected in such tide-dominated estuaries that reworking of the barrier dune by wave action should move it back more or less to its previous orientation within a relatively short period,²³ and this movement is evident by July 2008. It had also accumulated subaerial sand.

By December 2008, the ebb flow had continued eroding the consolidated muddy western boundary, while much of the shallow sandbank in front of Poortjies had been removed. Of particular interest are the changes to the barrier dune in that a new channel had developed about 200 m to the northeast of the main mouth channel. Moreover, the section of barrier dune shown was submerged at high tide, and even though the water levels at the time of measurement were some 200 mm higher than in July, the indications are that additional erosion had occurred; there were also several washover points further north.

It appears that extreme wave events, such as those of September 2008, can also cause breaching of the barrier dune. The channel evident in December 2008 (Figure 7) remained operative for more than a year before it was eventually closed when the northward extending longshore delta became too long.

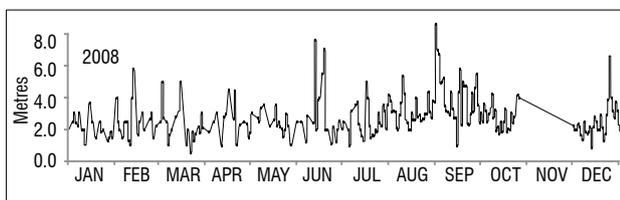
Figure 8: Daily significant wave heights from voluntary observing ships data for 2008. The dots indicate the values of wave height, joined by the thin line. There are numerous days when there were no data.

The reasons for the changes can then probably be found in Figure 8. The VOS data showed that very high wave conditions occurred around 1 September, with wave heights greater than 8 m. At the time there was also considerable damage reported from other coastal areas along the south coast. Such storm waves would have eroded the barrier dune, with extensive washover areas occurring. One such washover was probably sufficiently large to form a channel, and once formed, water would have selectively exited along this channel. Moreover, the waves penetrating over the barrier dune would have been responsible for the erosion of the sand delta at Poortjies.

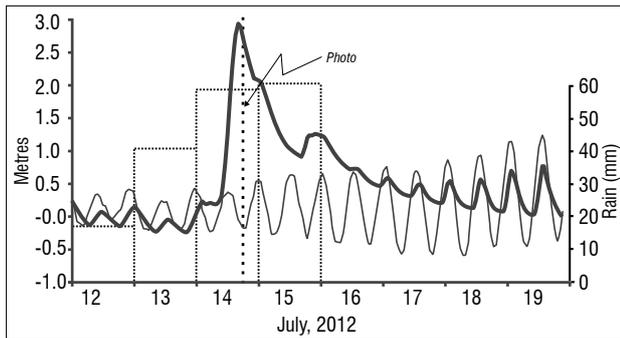
Figure 9: Hourly sea level data from Mossel Bay (light line), hourly water level data from the N2 gauge (dark line), and daily rainfall records (dotted line). The time at which the photo in Figure 11 was taken is shown.

The rainfall, sea level at Mossel Bay, as well as the water level at the N2 gauge are depicted in Figure 9, starting on 12 July and ending eight days later when conditions had returned to normal. In addition, Figure 10 shows that high wave conditions were experienced at the time, with peak wave heights close to 8 m being reported. Inspection of Figure 7 shows that in July and October 2011, overwash points were observed on the barrier dune south of the more heavily vegetated section. These points were evident, both from a lowered dune profile where waves had penetrated over the dune, and the washover fans where sand had subsequently been deposited in the estuary. These points were particularly vulnerable to breaching by the floodwaters and Figure 9 shows that the water level in the estuary rose rapidly from about midday on 14 July in response to the continuing rain from 12 July onwards. Such a damming up of water behind the barrier dune would have been caused by the convoluted exit channel past Poortjies being too small and obstructive to accommodate the volume of water flowing into the estuary.

The neap tide on 12 July and the ebb tide early on 14 July allowed more water to flow out thereby checking the rising water levels for a short time. The following flood tide served to limit this outflow, and the water level in the estuary rose rapidly. The high waves at the time would also have caused a wave set up thereby further blocking up the water in the estuary.

The flood water level reached its maximum and then from about 5pm on 14 July there was a rapid decrease. The reason for this decrease can be seen in the photograph in Figure 11, taken just after the peak water level had been reached (Figure 9).

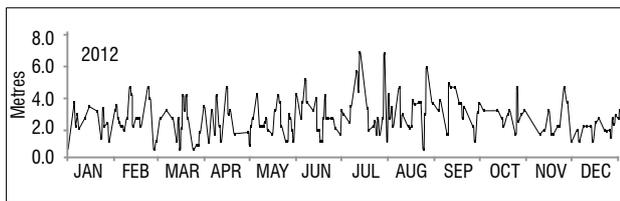
Figure 10: Daily significant wave heights from voluntary observing ships data for 2012.

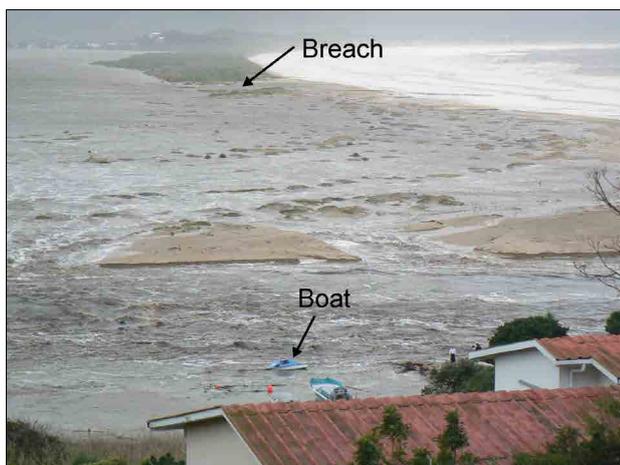
Figure 11: Photo taken at the time of the breach of the barrier dune (see Figure 9). The photo was taken from the square on Sydney Street depicted in Figure 7, October 2011.

It is apparent that a combination of the high water levels in the estuary, as well as probable overwashing from the high sea waves caused a breach in the barrier dune at the position indicated. This was an old overwash position observed in both July and October.

At the same time, the mass of water going over the southern part of the barrier dune and flowing directly to a position just northwest of Milkwood Manor can be seen. Here the rocks deflected the water to the

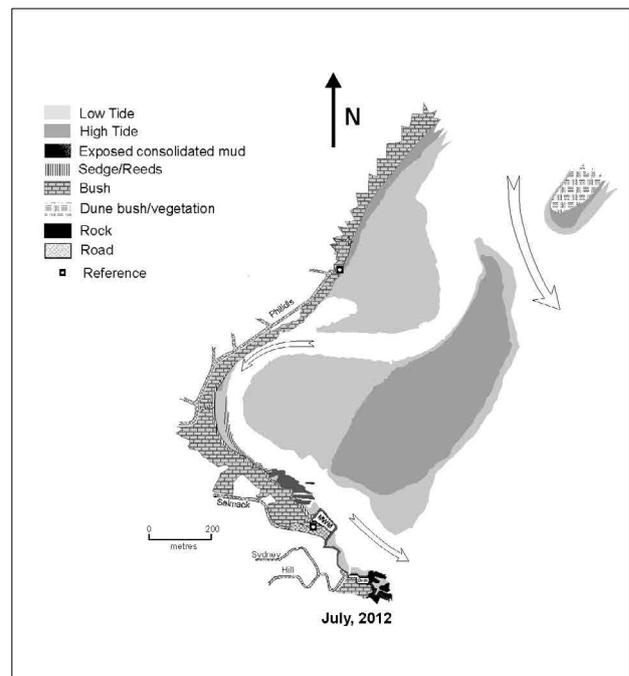
Figure 12: Keurbooms Estuary sediment structures after the breach of the new mouth in the northeast. Ebb current flows are indicated.

The surveys carried out on 17, 18 and 19 July are depicted in Figure 12 and show the new estuary configuration. The new mouth was situated about 1 km from the Lookout Rocks and was accommodating a substantial volume of the tidal exchanges. The remaining barrier dune was still intact, but was now an island between the two mouths. The sand delta extending from the reference point on the western bank of the estuary was still largely intact. Most of the floodwaters exited through the new mouth and thus did not pass and erode this delta.
